Bell Bay Aluminium Annual Environment Report

2024

This Annual Environmental Report has been prepared for the Bell Bay Aluminium smelter. It supports and describes the metallurgical works, aluminium smelter operations and associated activities.

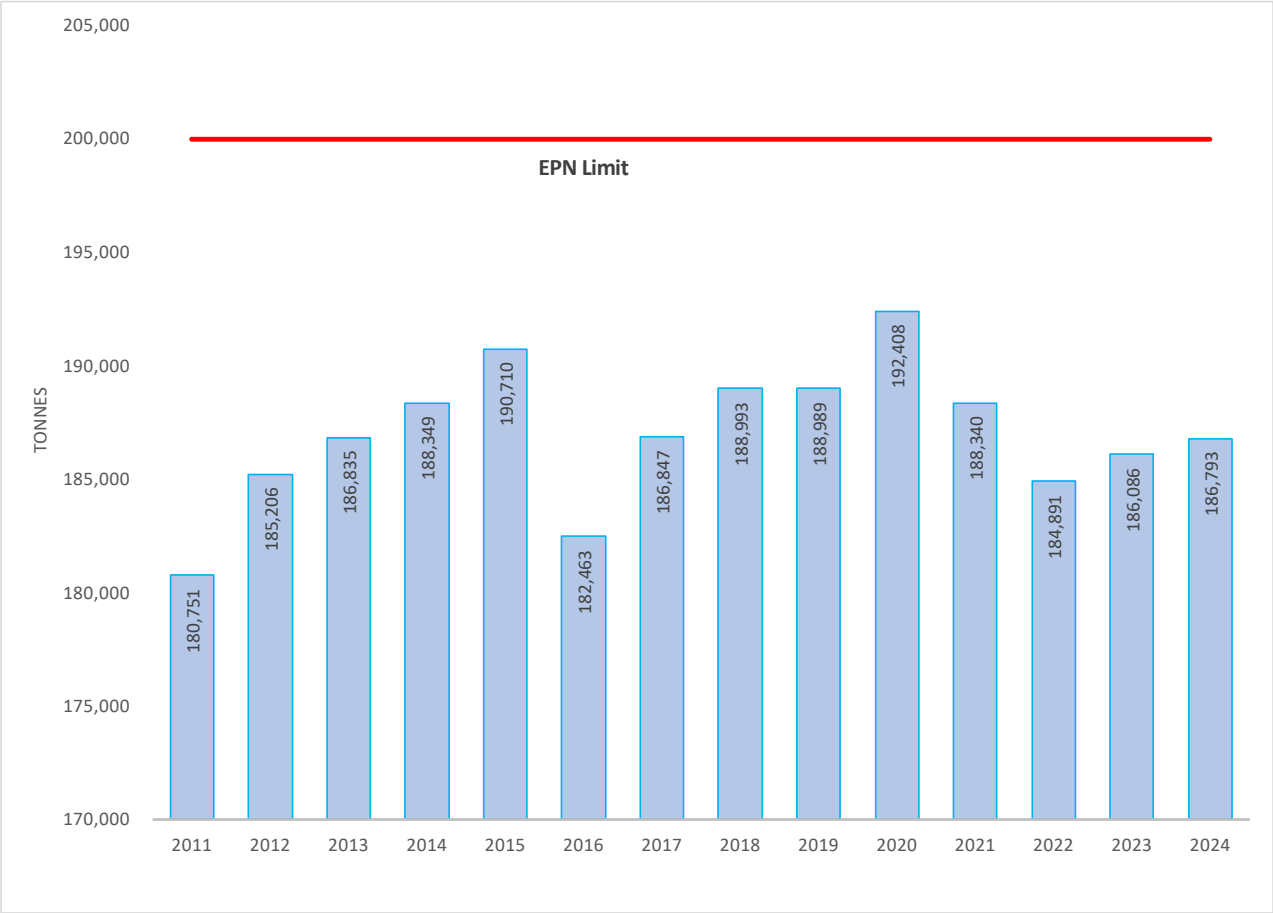
Figure 2: hot metal production 2011-2024

The primary factor contributing to the discrepancy between the planned and actual production was an elevated number of non-operational cells, following an extended outage in Potline 4.

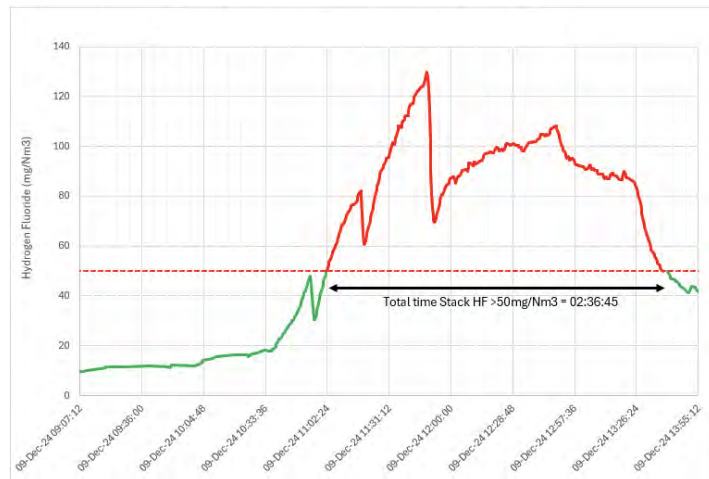
Figure 3: exceedance period in graphical format

On 9 December at 4.30am, an event occurred during the process of filling the tanker (a pressure vessel used to transport alumina from the bulk store to the dry scrubber) at the bulk store. The chutes and tanker were damaged because of the event which necessitated immediate repairs before operations could resume.

Due to the repairs, the alumina flow rate to the reactors at the dry scrubber was temporarily reduced. The extended repair timeframe led to the depletion of alumina in the primary silo. Consequently, the scrubber was unable to effectively scrub the fumes, resulting in an exceedance of the hydrogen fluoride (HF) limit of 50 milligrams per cubic meter (mg/m³) for more than 60 minutes.

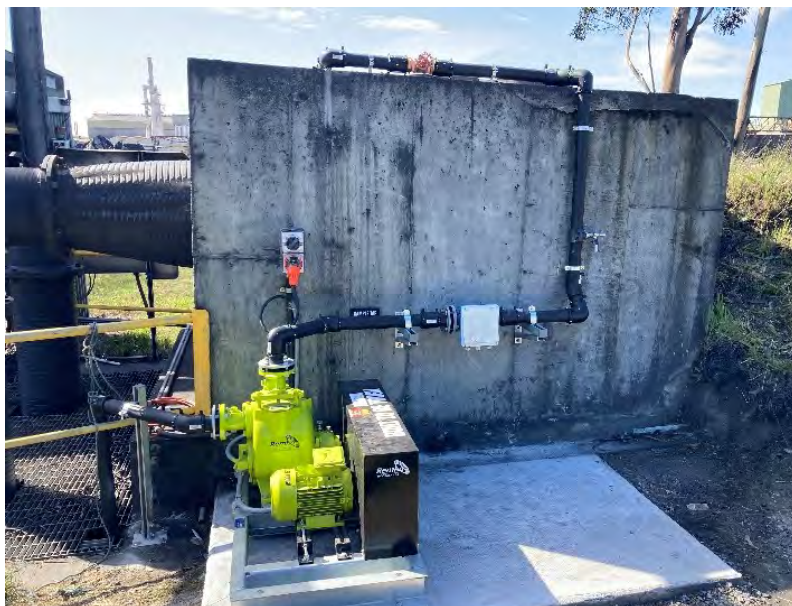
Figure 7: new sampling pump

Despite replacing the pump three times during 2022-23, failures persisted. The root cause was determined to be the build-up of solids within the pit where the pump was submerged. To resolve this issue, the pump location was changed to an above-ground position, improving asset integrity and simplifying maintenance in the event of any future failures and repairs.

The pump was successfully installed and commissioned in November 2024, restoring the reliability of sampling in the south drain area.

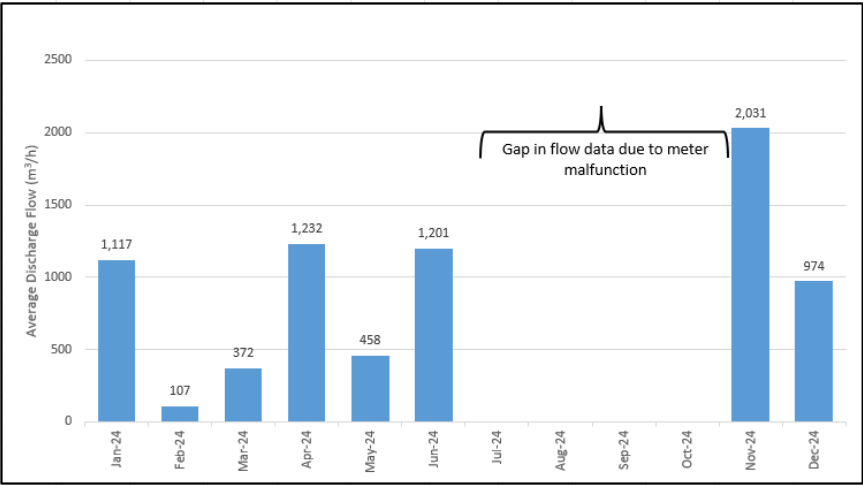
Figure 9: average discharge flows per month in 2024

In 2024, the total volume of water discharged from the main drain outfall was estimated to be **339,940kL**. The monthly average flows can be seen in the figure 9:

However, there was a data gap from 1 July 2024 to 15 November 2024 due to a flow meter malfunction caused by a data connection fault between the logger and the data recording system. This led to the loss of that period of data. As a result, estimates for the missing data were made based on the quantity of rainfall received at the site during the affected months.

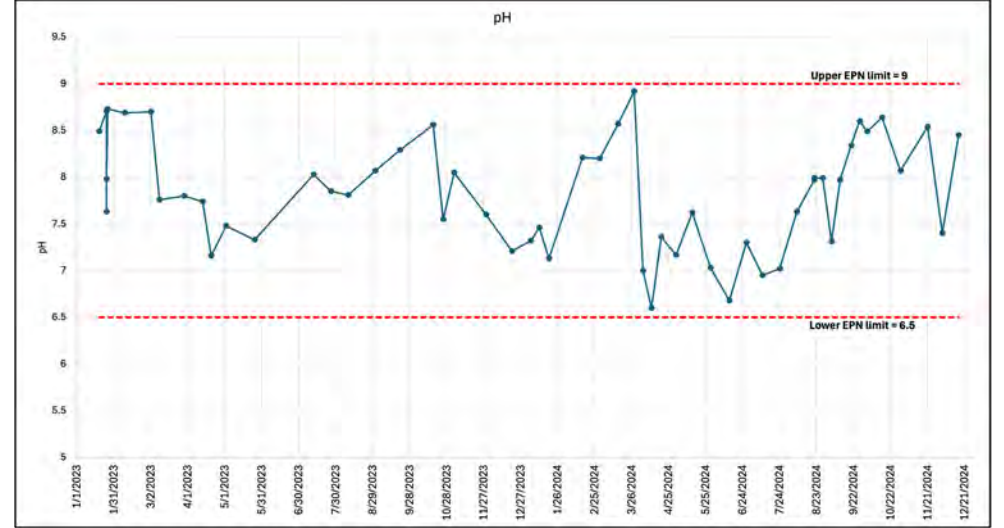
Figure 12: pH versus site EPN limit

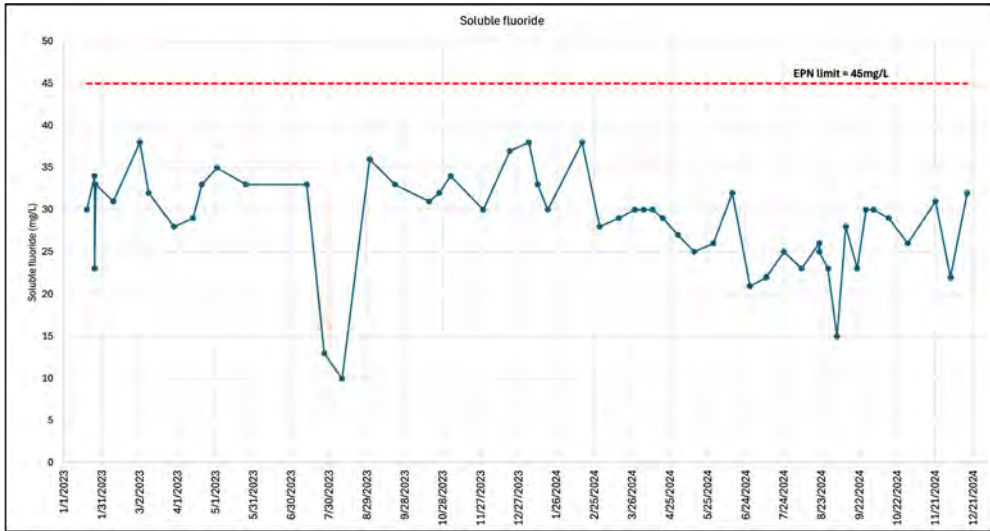
Figure 11: soluble fluoride versus site EPN limit

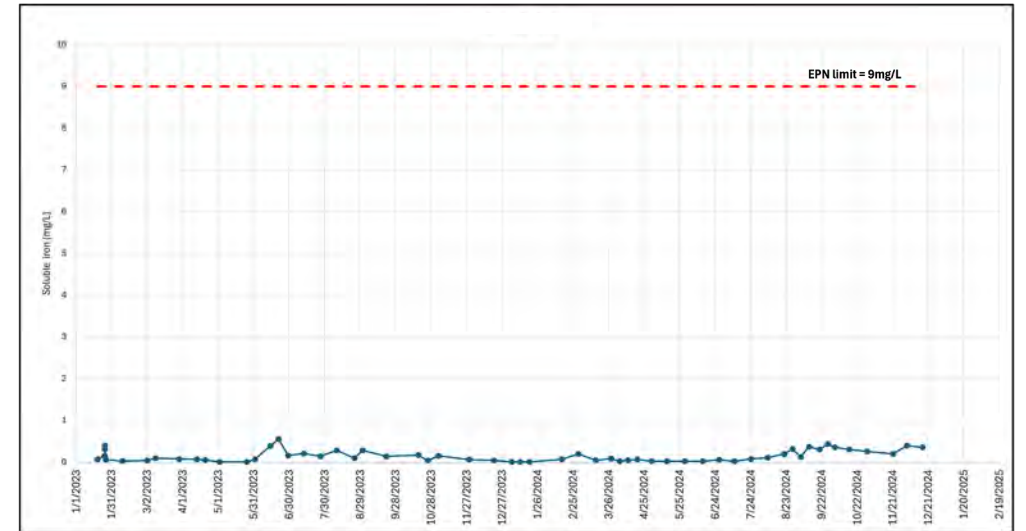
Figure 13: soluble iron versus site EPN limit

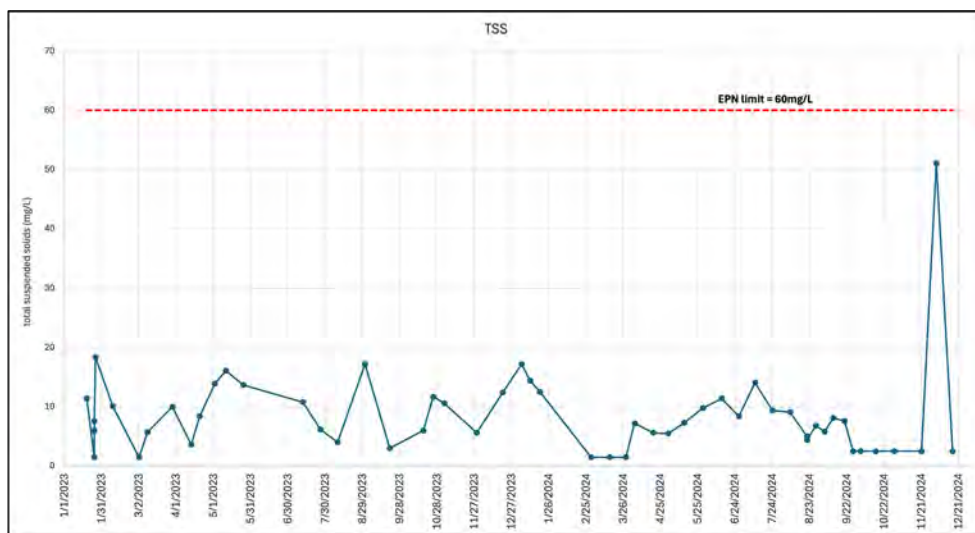
Figure 14: total suspended solids versus site EPN limit

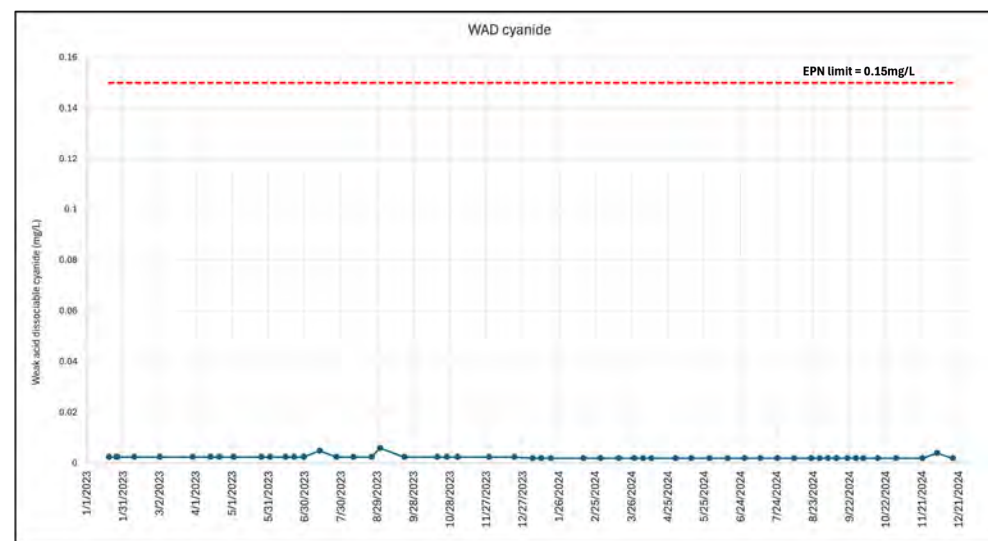
Figure 16: weak acid dissociable (WAD) cyanide versus site EPN limit

Note: All measured values were below Practical Quantification Limit (PQL) and therefore displayed with a value of 0.5 * PQL

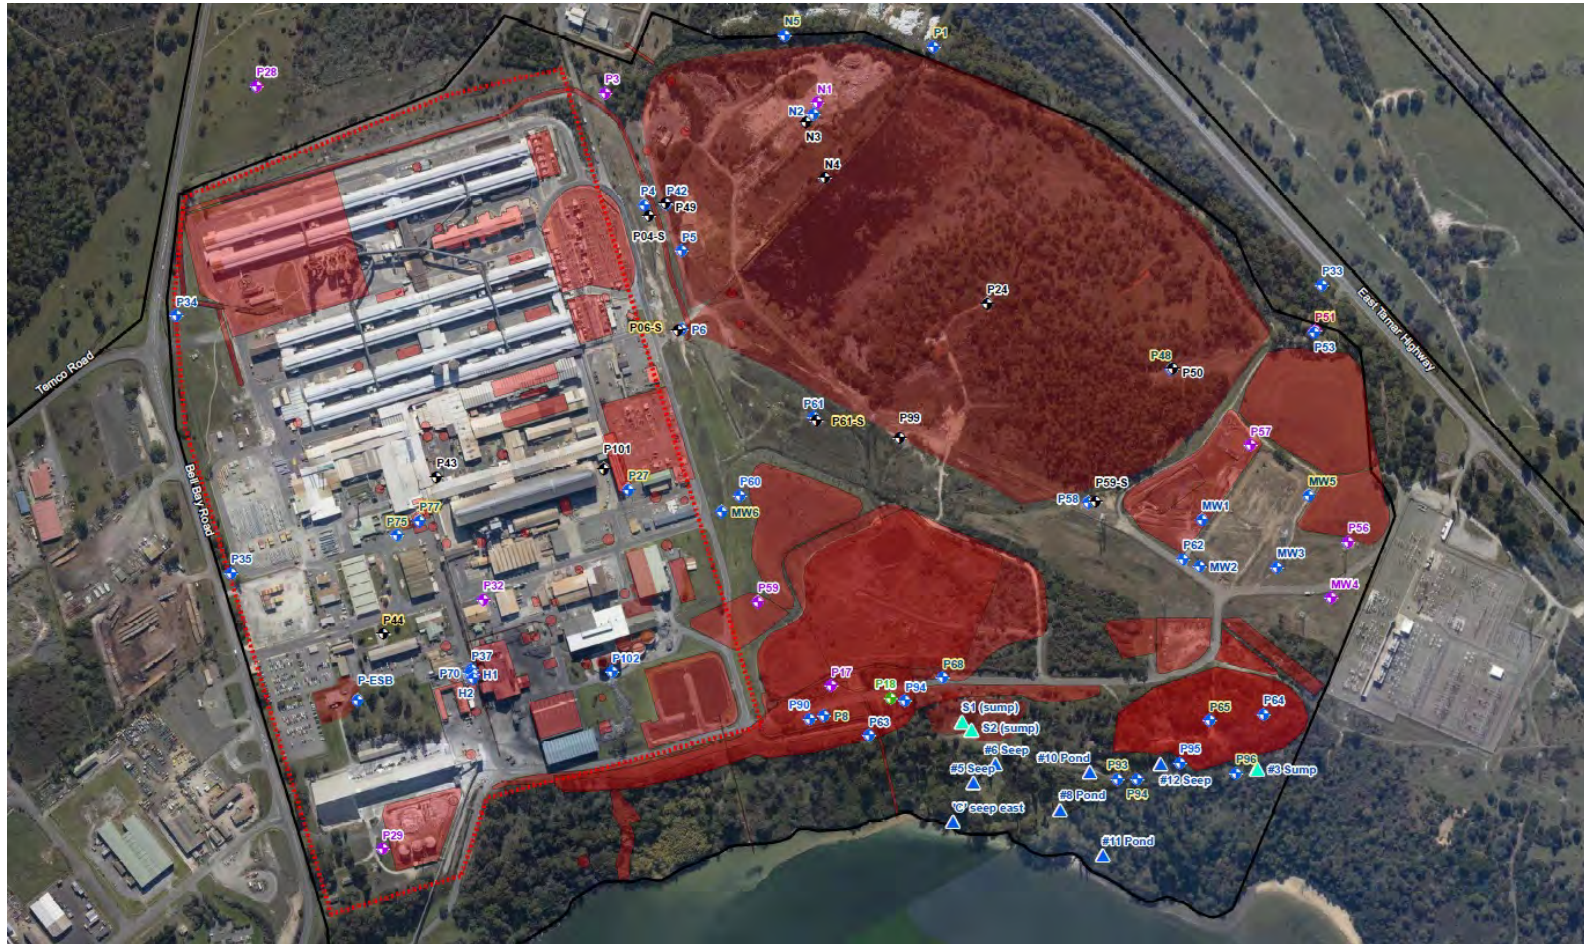
Figure 17: groundwater monitoring sample locations

Two borehole sampling events were undertaken during February and October 2024.

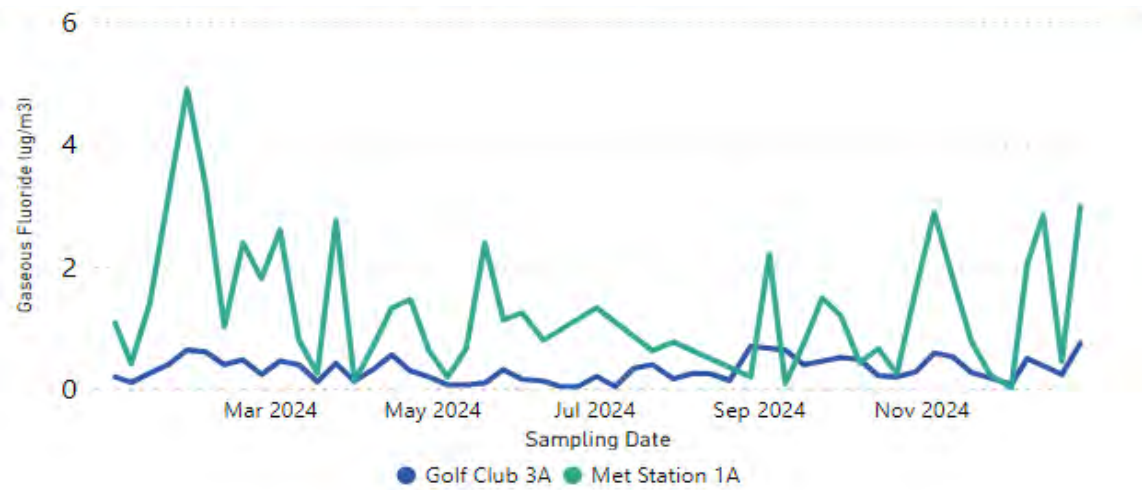
Figure 28: seven-day average ambient air results for sites with Bell Bay Aluminium’s compliance limit boundary

It should be noted that the EPN limits apply to the locations outside this boundary. The seven-day, 30-day and 90-day averages of monitoring stations within the compliance boundary are summarised in figures 28, 29 and 30 below:

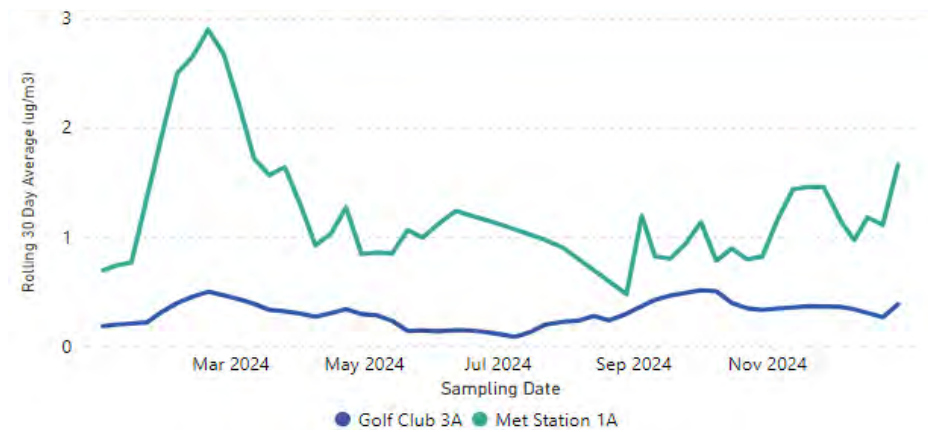
Figure 29: 30-day average ambient air results for sites with Bell Bay Aluminium's compliance limit boundary

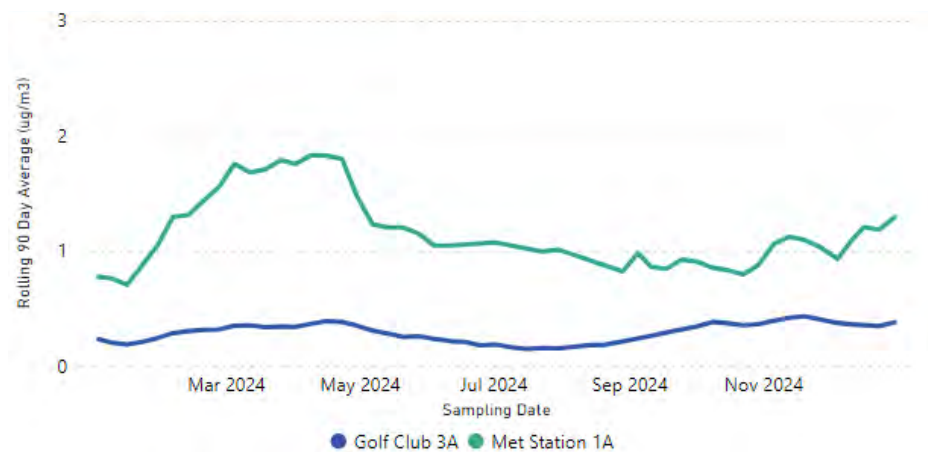
Figure 30: 90-day average ambient air results for sites with Bell Bay Aluminium's compliance limit boundary

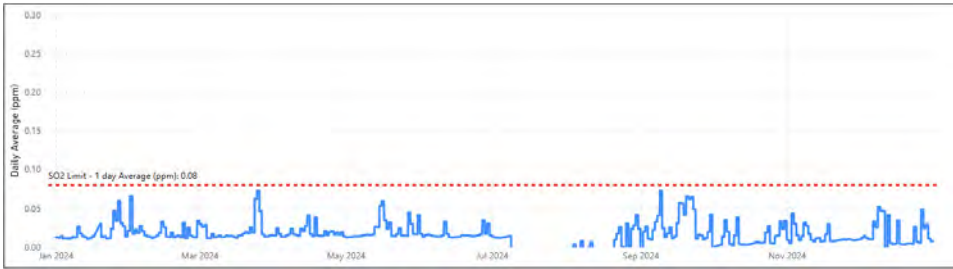
Figure 43: ambient SO₂ monitoring compliance to 24-hour limit
